Garden of the Gods Trail Assessment

December 2018

CITY OF COLORADO SPRINGS
PARKS, RECREATION AND CULTURAL SERVICES

ROCKY MOUNTAIN FIELD INSTITUTE
815 SOUTH 25TH STREET, SUITE 101
COLORADO SPRINGS, CO 80904

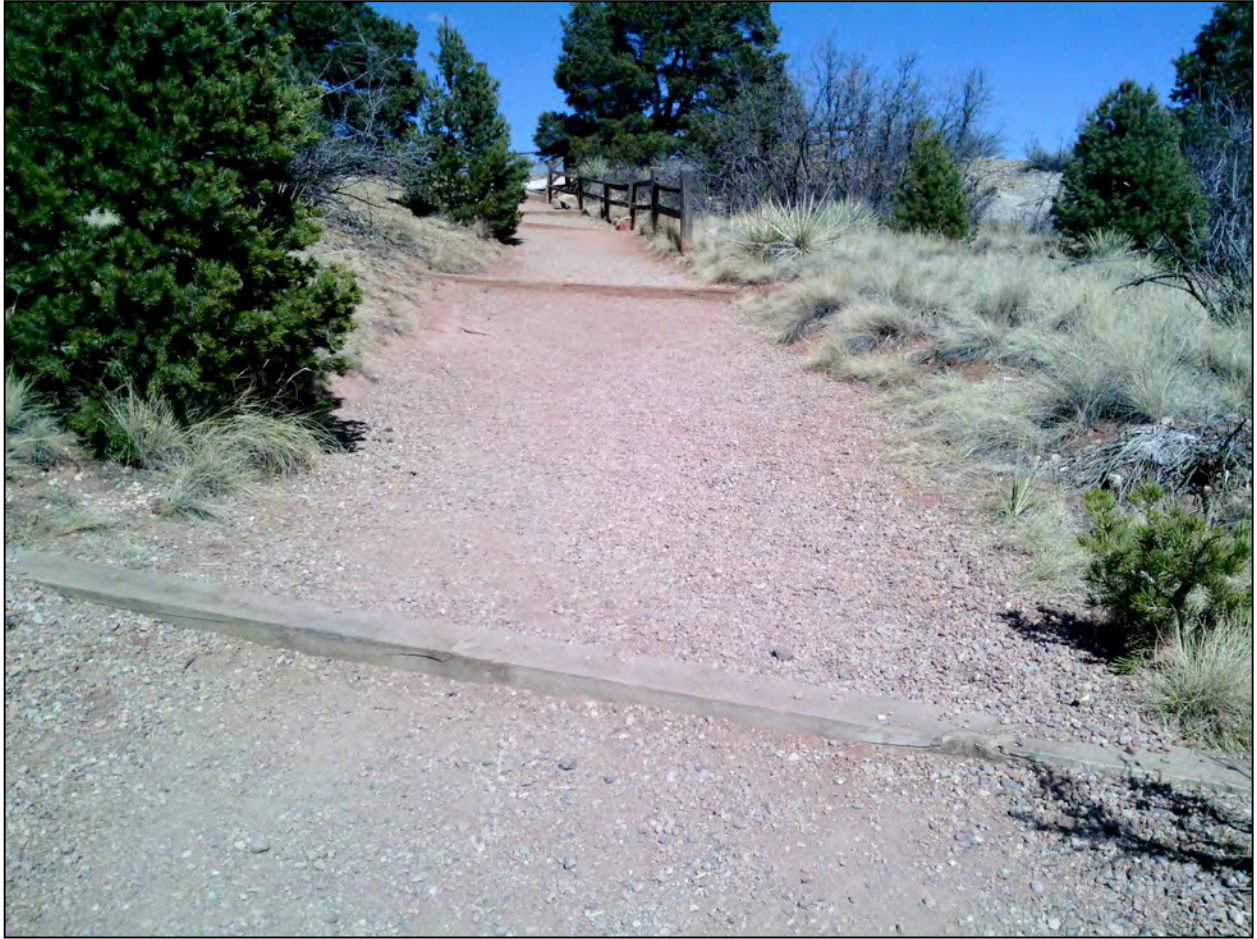
Figure 1. An example of an A-rated primary trail in the Garden of the Gods Park (Ridge Trail).

2. **Ridge Trail Loop:** The Ridge Loop Trail, a hiking only trail, received a score of 9.52. The assessment recommends maintaining 13 features and installing 1 new feature.

Recommendation: Monitor for future needs.

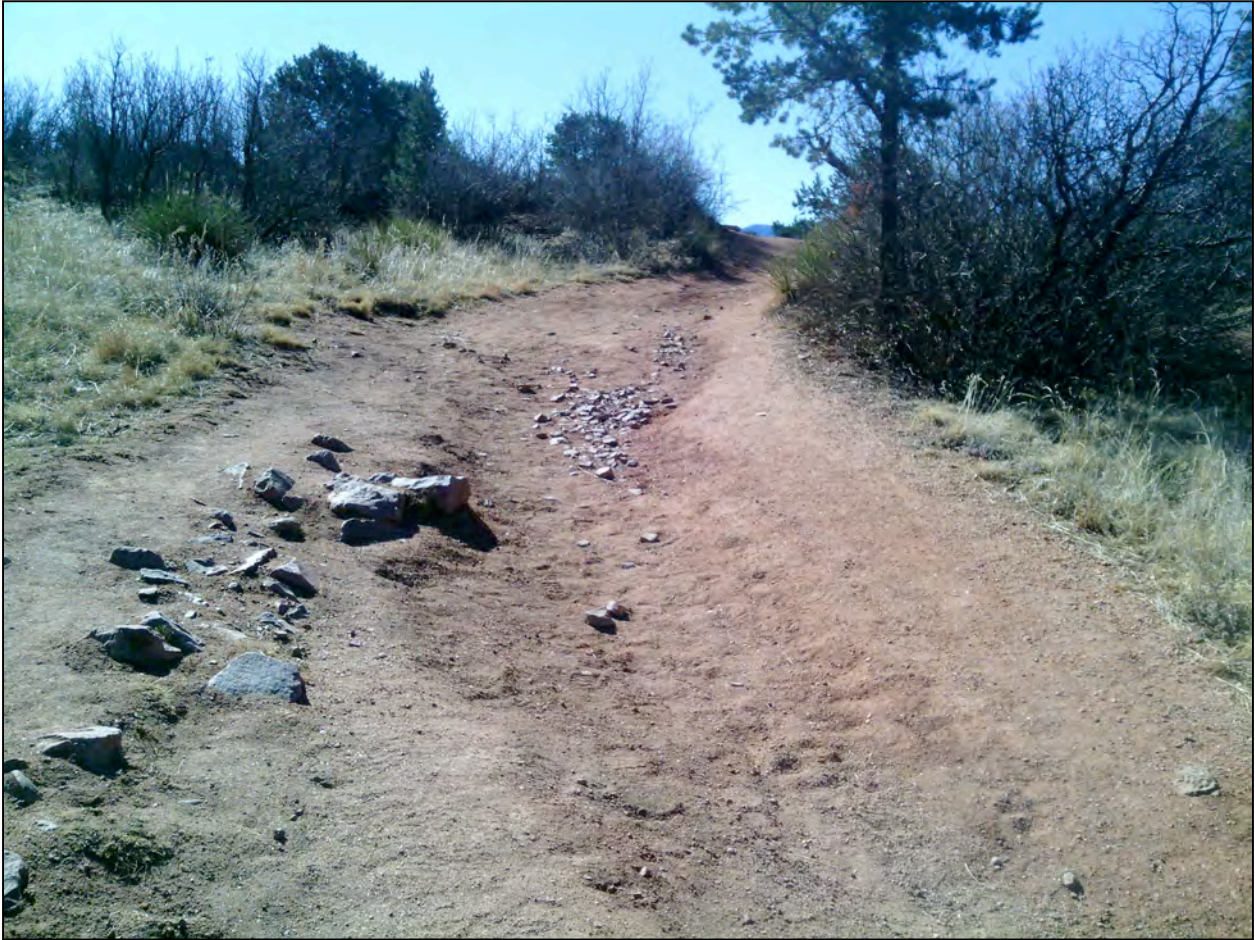
Figure 2. An example of a B-rated primary trail in the Garden of the Gods Park (Chamberlain Trail).

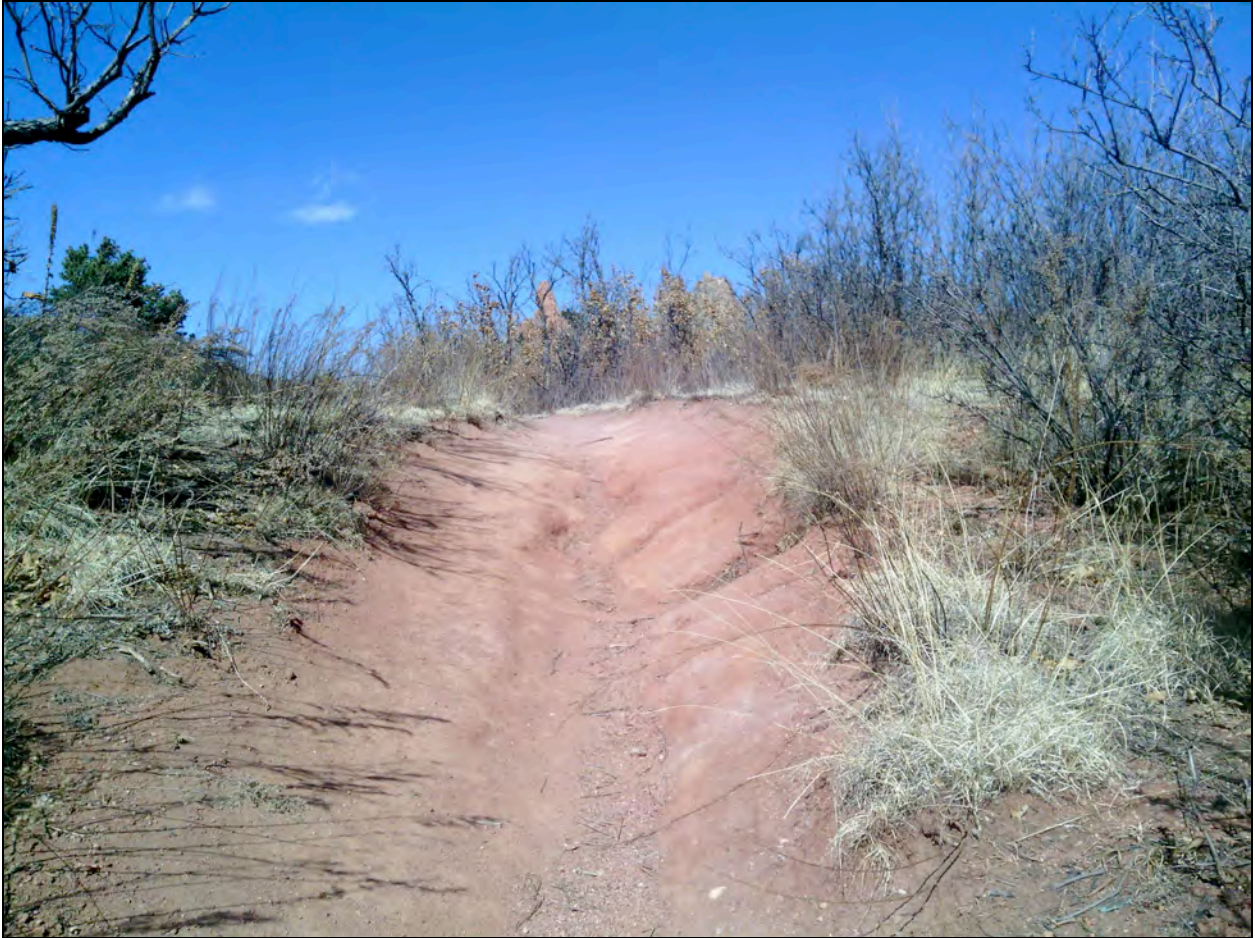
Figure 3. An example of a C-rated primary trail in the Garden of the Gods Park (Arnold Trail).

1. **Arnold Trail:** The Arnold Trail received a score of 7.87. The 0.18-mile long trail is named after the road where the trail begins in the most southern area of the Park. The Arnold Trail is most popular with hikers who access the trail via the neighborhood. There are 6 features that need to be constructed, 2 features that need repair/replacing, 4 features that need maintenance, and 2 features that require no action. There are no measurable natural resource issues observed on this trail.

Recommendation: The Arnold Trail would benefit from construction and maintenance of drainage structures; however, the trail is not a high priority at this time. Monitor for future needs.

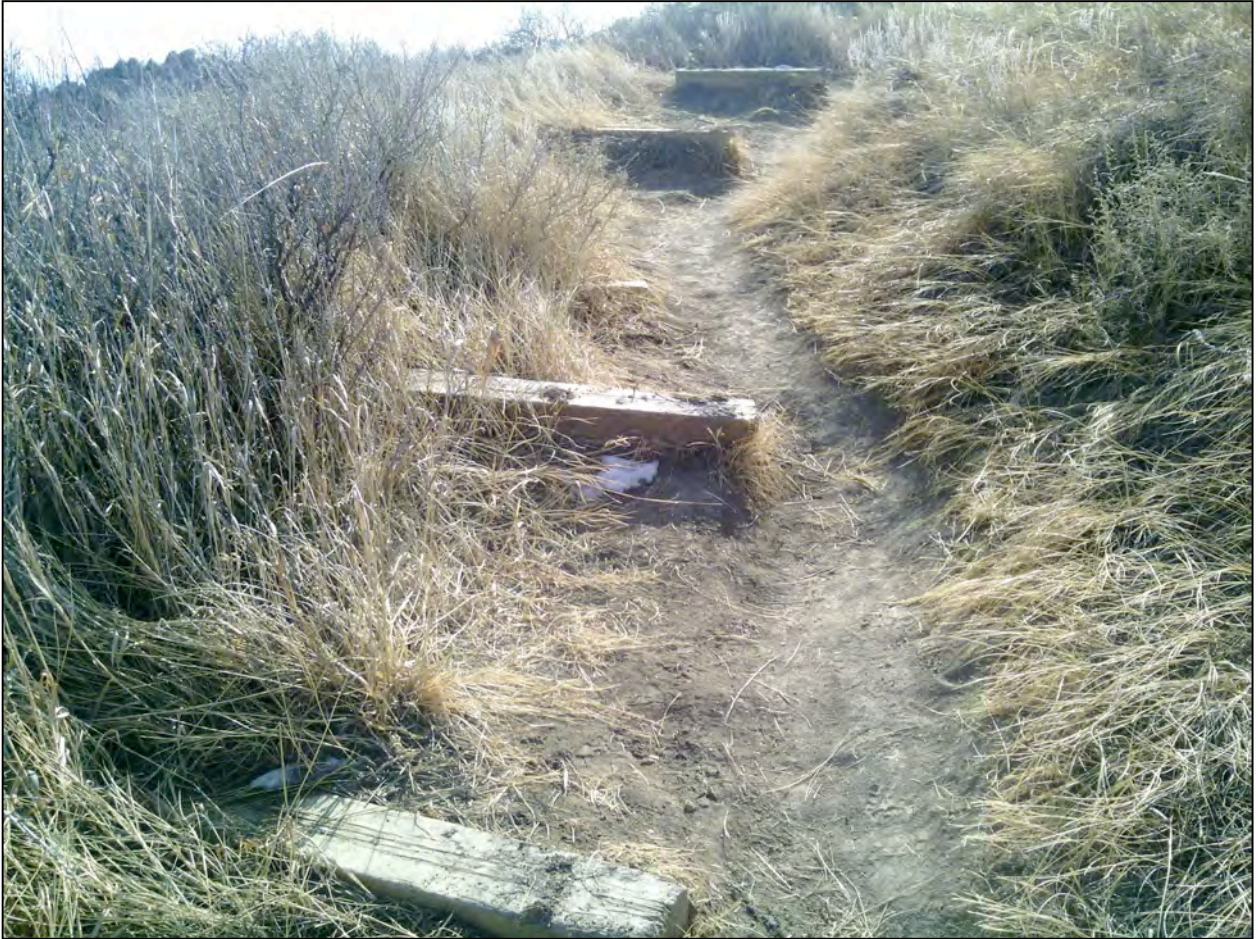
Figure 4. An example of a D-rated primary trail in the Garden of the Gods Park (Dakota Trail).

1. **Dakota Trail:** The Dakota Trail received a score of 6.93. This trail is located on the north end of the Park and is 0.43-miles long. It connects the Bretag and Foothills Trails and provides Park access via the Foothills Trail from the north. Nine new features need to be installed and 1 feature has failed. Overall, the Dakota Trail is in fair condition, but it received a low score due to areas of incision (540 ft³) and erosional braiding (9 ft³).

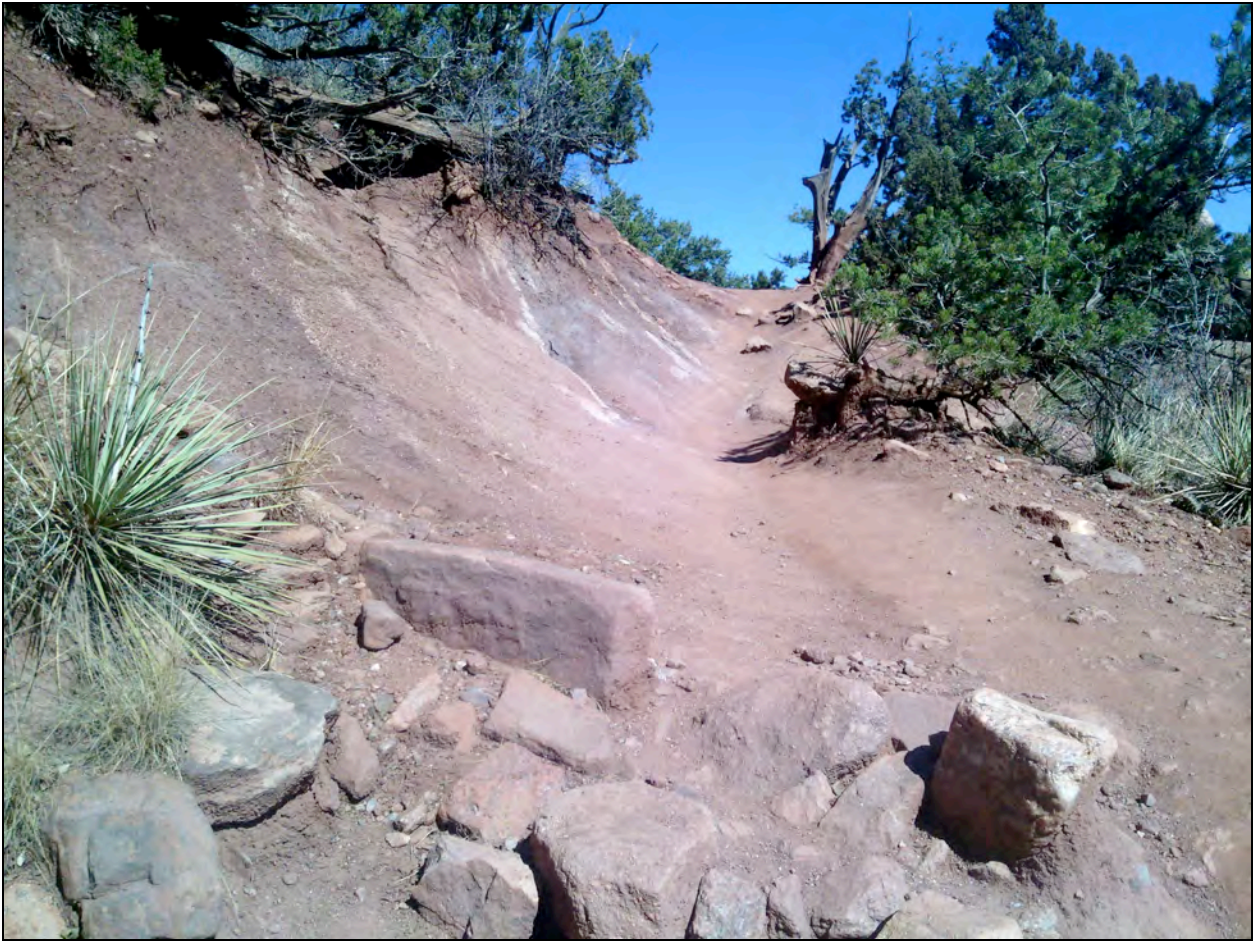
Figure 5. An example of an F-rated trail in the Garden of the Gods Park (Palmer Trail).

RMFI recommends first addressing the severe issues, all of which were erosional issues recorded along the Palmer Trail (3 in total and encompassing a combined length of 259 linear feet, an average width of 165 inches, and average depth of 33 inches). None of the connector trails had severe issues. These should take priority because they have the potential to impact user safety and cause continued degradation of the surrounding natural resources. In November 2018, RMFI began a variety of projects along the Palmer Trail including constructing rock riser steps and drains, hardening portions of the trail, and maintaining existing features along the trail including drains, water bars, and rock riser steps, all of which will help address the severe issues recorded on the trail during the assessment (as well as the major, moderate, and routine maintenance issues).

There were only 14 major erosional issues recorded, and all were on the Cabin Canyon, Palmer, and Strausenback Trails. As with the severe issues described above, the action involved with addressing major issues generally involves the repair and rehab of the area through a variety of erosion control, stabilization, and drainage enhancement techniques. The same actions hold true for trails exhibiting moderate erosional issues, which represented the majority of the issues (73%) recorded during the assessment. Given the extensive nature of the moderate issues in the Park, RMFI expects to devote a significant amount of time early in the implementation phase addressing these issues. During the 2018 field season, RMFI began extensive projects on the Strausenback Trail, Palmer Trail, Ute Connector Trail to begin addressing some of these erosional and natural resource degradation issues.

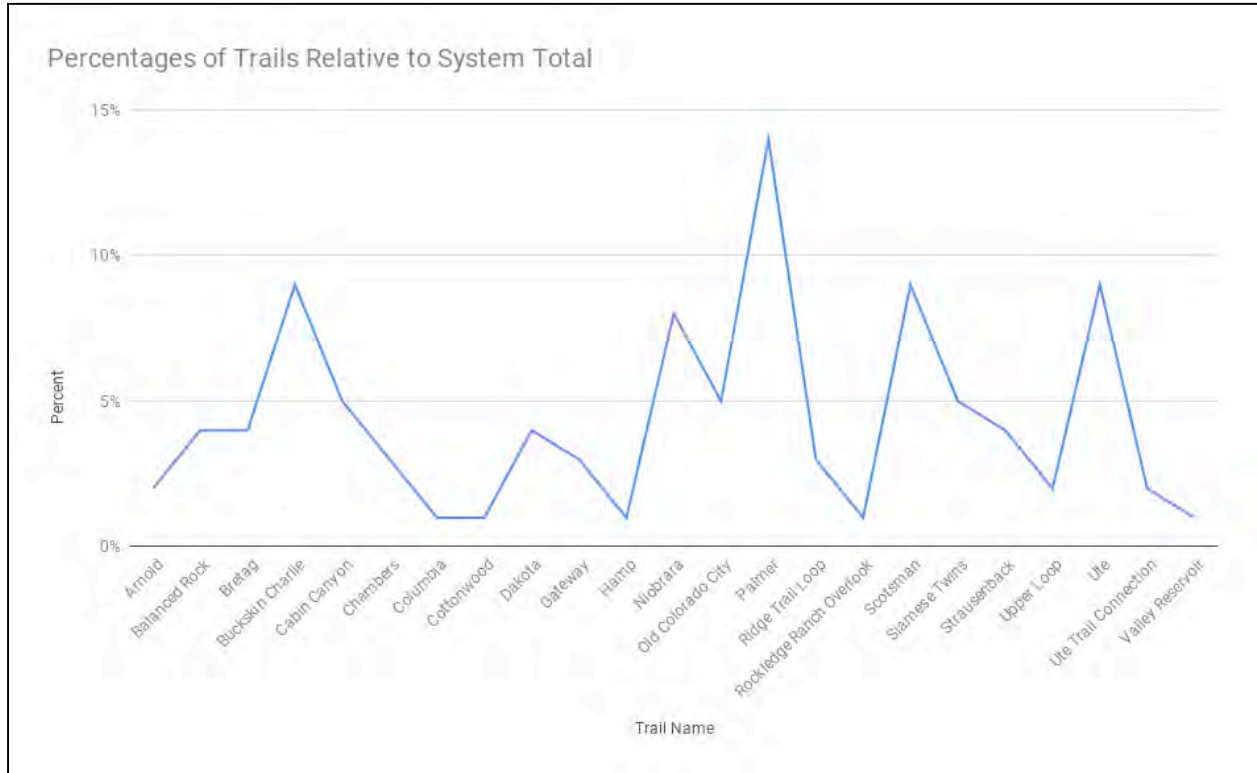
Figure 6. Percentage that each individual trail accounts for relative to the entire trail system in the Garden of the Gods Park.

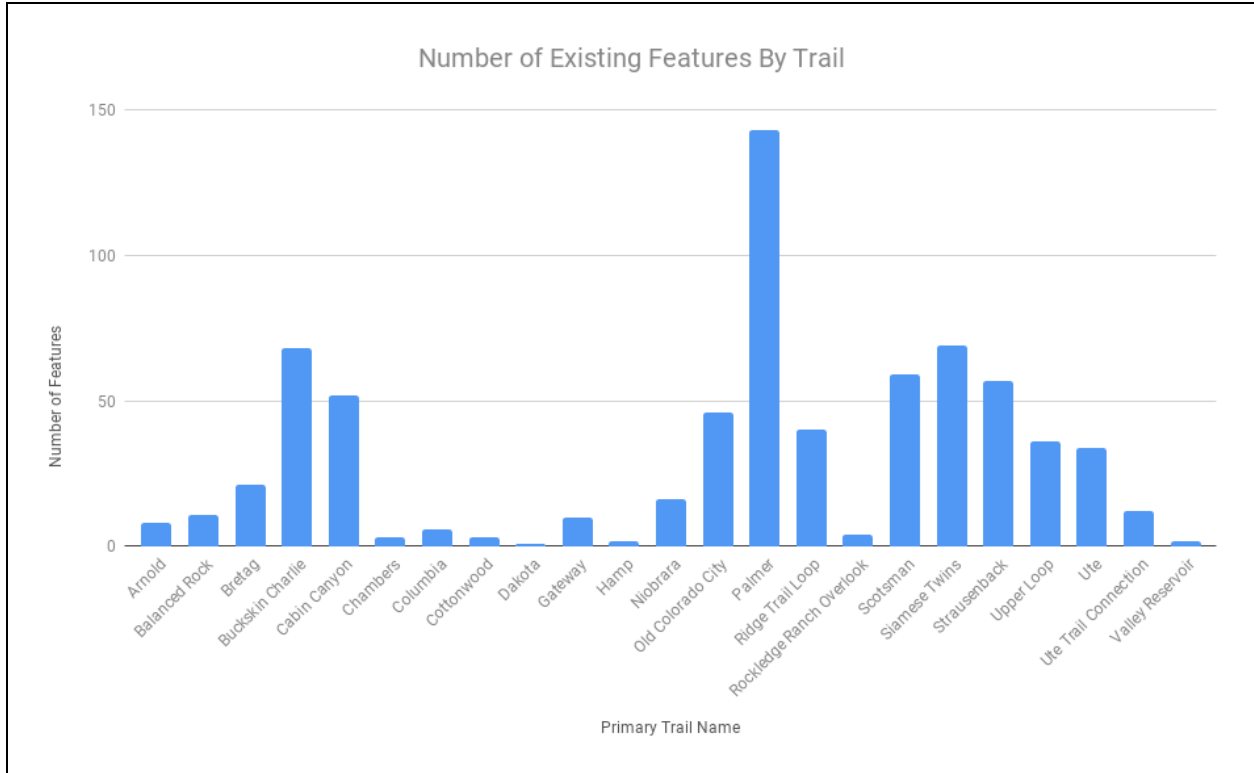
Figure 10. Number of existing features on the 23 primary trails in the Garden of the Gods Park.

A total of 861 features were recorded across all primary trails included in the assessment, including 703 that currently exist and 158 new features needing to be installed. Table 3 details number and condition of features on each of the 23 primary trails in the Park (i.e., install new, failed, near failed, repair, maintain, no action). Approximately 33% of all existing features require routine annual maintenance (drains, culverts) and 44% of all existing features require no action at this time. Figures 7 displays all trail features and their condition across the Park; Figure 8 displays only the new features requiring installation; Figure 9 displays all features requiring no action at this time; Figure 10 displays the number of all existing features by trail.

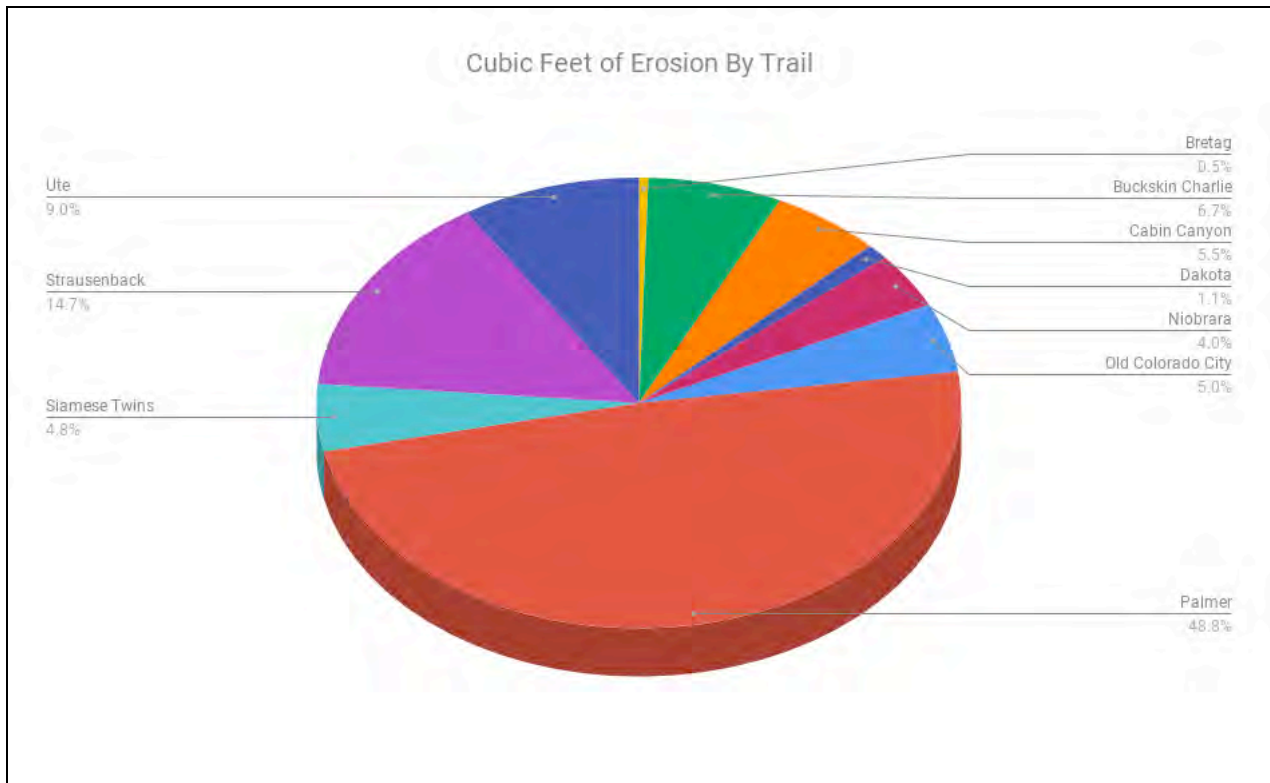
Figure 11. Cubic feet of erosion recorded on the 23 primary trails in the Garden of the Gods Park.

A total of 202 issues (occurrences of resource damage) were recorded throughout the trail system. There was 48,414 cubic feet of erosion (23,618 ft³ on the Palmer Trail alone), 318 feet of trail braiding, and 2,477 cubic feet of trail widening observed on 13 of the 23 primary trails included in the assessment. Table 4 details issues observed on each of the 13 primary trails. Figure 11 graphically displays cubic feet of erosion recorded during the trail assessment.
