Severy Creek Basin Analysis

Pikes Peak, El Paso County, Colorado

Report prepared by:

Rocky Mountain Field Institute

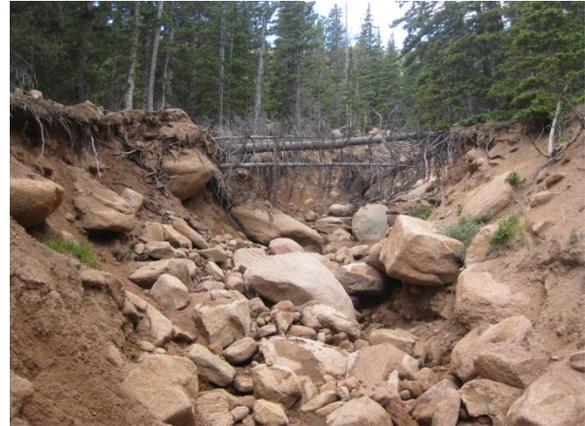
Figure 3. Example of gully channel leading into the alluvial fan.

The source of the alluvium in the fan is from several major gullies that have formed in the upper reaches of the basin where it is bisected by the Pikes Peak Highway. Several culverts and ditches previously found along this portion of the highway augmented flows into the Severy Basin by acting as a conduit directing runoff from other basins into Severy Creek. The flows caused several large gully channels to develop off the highway (Figure 2). The gully channels are up to 1100 m in length and average 6-9 m deep and 9-12 m wide (Figure 3). The eroded

material from these channels provided the sediment source for the alluvial fan and the volume of sediment is estimated to be upwards of 32,500 m³.

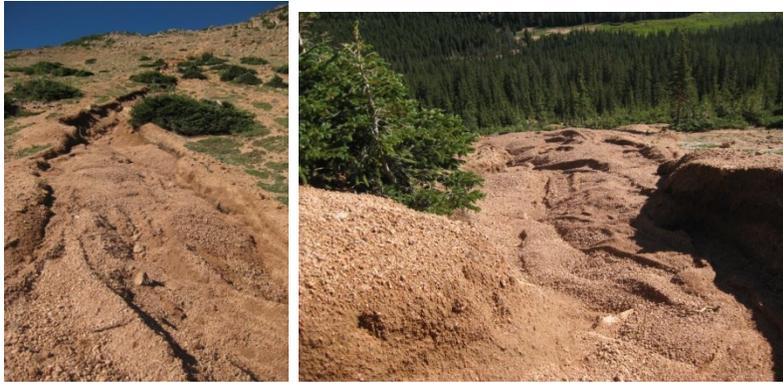
Figure 32. Sediment aggradation during the summer of 2010 along cross-section XS2.

noted above. Data shows little change with regards to bank location and width of channel with occasional significant changes in channel depth. Along gully NG1, significant changes in channel depth were recorded in 2010 along transects XS1 and XS2. Channel depth increased by 1.15 m along cross-section XS1 between measurements taken in June, 2010 and mid-August, 2010 (Figure 30). The material that was removed from the channel floor along this reach was re-deposited in the channel eighty meters further down at cross-section XS2. Here the channel depth increased by an average of 1.13 m (Figure 31). Since data were first collected in 2008 the channel in this area has aggraded over 2 m to where it is now almost completely refilled (Figure 32).

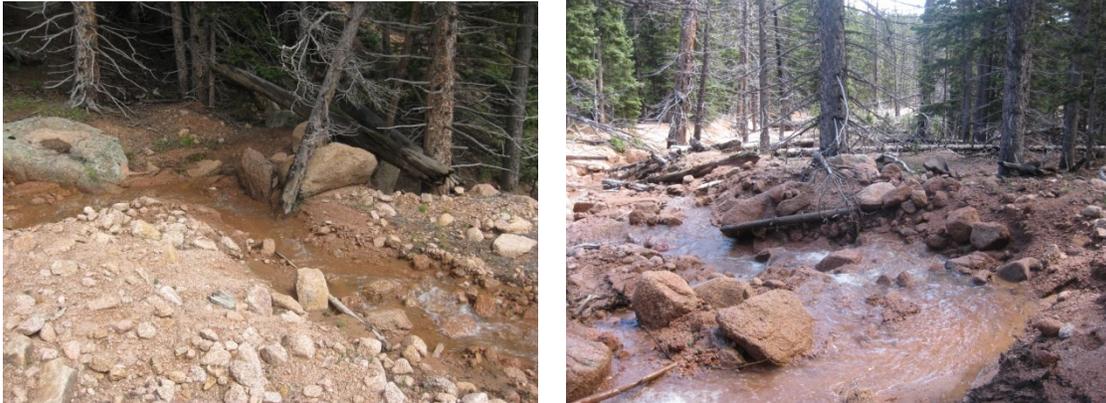
Figure 35. Photographs showing the debris banks protecting reactivating old channels within the upper fan.

on the other side of an actively eroding debris bank (Figure 35). The upper, northern most channel is the most likely to be reoccupied and could increase stream energy on the bank protecting the lower, southern channel. Reactivation of the southern channel would intersect with the channel believed to be occupied in 1997 and cause the same sediment issues as mentioned above.

The most permanent option to deal with the sediment in the alluvial fan would be for its removal to a safe location preferably outside of the basin. The construction of a new road into the basin would be required for such an operation and is undesirable due to the impact that construction activity would have on forest lands above the wetland. Previous reports have proposed removing the sediment through the use of heavy machinery flown into the project area by helicopter and then finding a suitable site within the basin for storage (Cooper, 1998, Cooper & Gage, 2008). Based on the calculations from this study of the amount of sediment deposition in the alluvial fan, a mound of sediment with a radius of 40 m and a height of 20 m would be required. There is not a suitable area within the basin that could contain such an immense volume of sediment other than keeping it within the confines of the existing alluvial fan deposit. This would be an undesirable option considering the expense and technical difficulties of removing and stabilizing the sediment only to leave it within an area where it could potentially impact the restored areas.

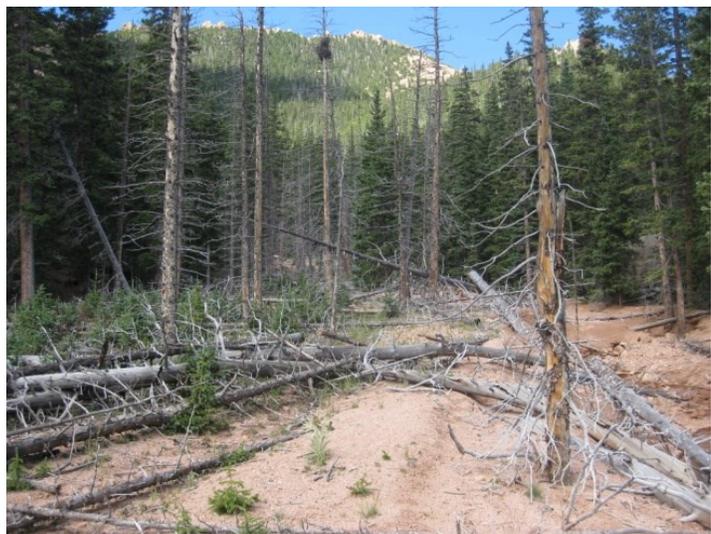
Figure 36. View of upper alluvial fan with Engelmann spruce saplings.

Along with stabilizing the stream channel, prescriptions would be implemented to increase vegetation cover throughout the fan. Already, Engelmann spruce saplings are re-colonizing areas in the upper fan that have now been stable for an estimated 15 to 20 years (Figure 36). It is recommended that additional saplings of both Engelmann spruce and Blue spruce be planted throughout the fan where appropriate to provide stability to the soils. Seeding of native grasses and forbs would provide additional cover and further stabilization. It is highly recommended that seed be collected within the basin starting in the summer of 2011 in order to provide for the seed stock needed to effectively revegetate the fan.
