Evaluation of Gully Erosion Control and Restoration Techniques in the North Crystal Creek Basin, Pikes Peak

Eric R. Billmeyer^{1,2}, Wendi Clouse², and Kyle Rodman²

¹Rocky Mountain Field Institute, Colorado Springs, CO 80904

²Department of Geography and Environmental Studies, University of Colorado at Colorado Springs, Colorado Springs, CO 80907

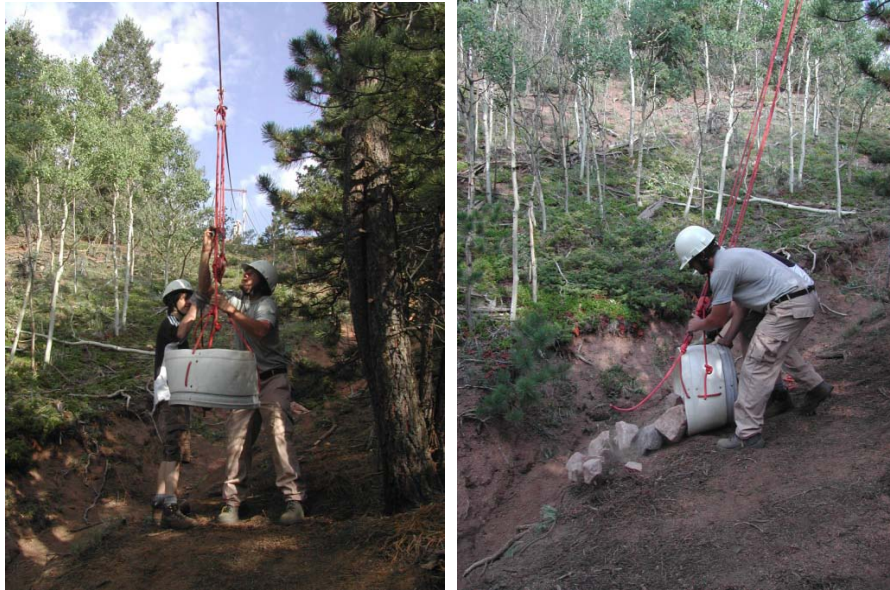
Figure 3 and 4. Examples of unloading the bucket from the tram set up.

and averaged 1 meter high. The rock tram was utilized to transport the rock 24 m from the staging area off the Pikes Peak Highway down into the gully (Figure 3 and 4). From there a team of 11 workers filled painters' buckets with 18 to 23 Kgs of rock and hand carried the material to the dam site (Figure 5 and 6).

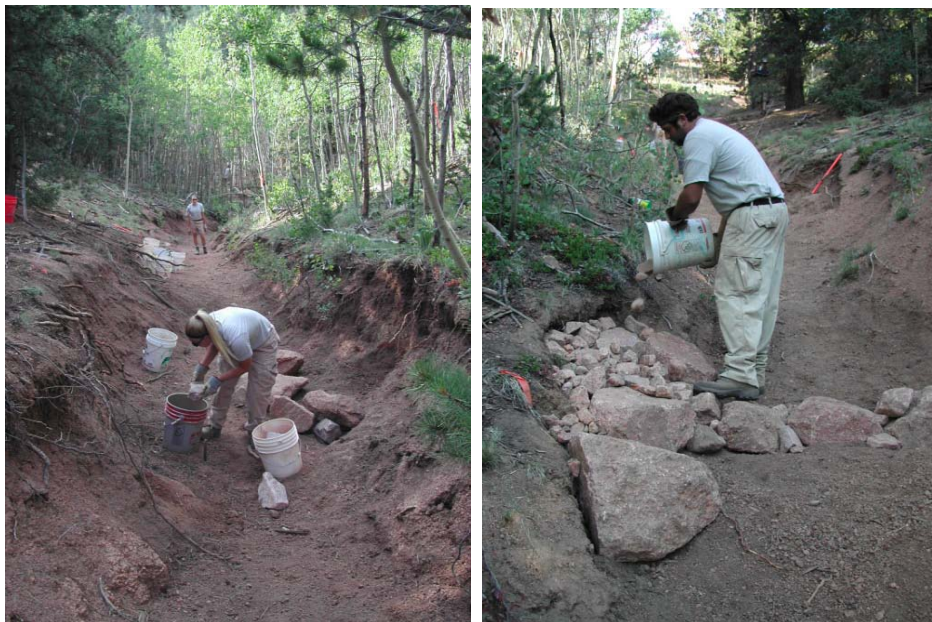
Figure 5 and 6. Examples of building the check dams.

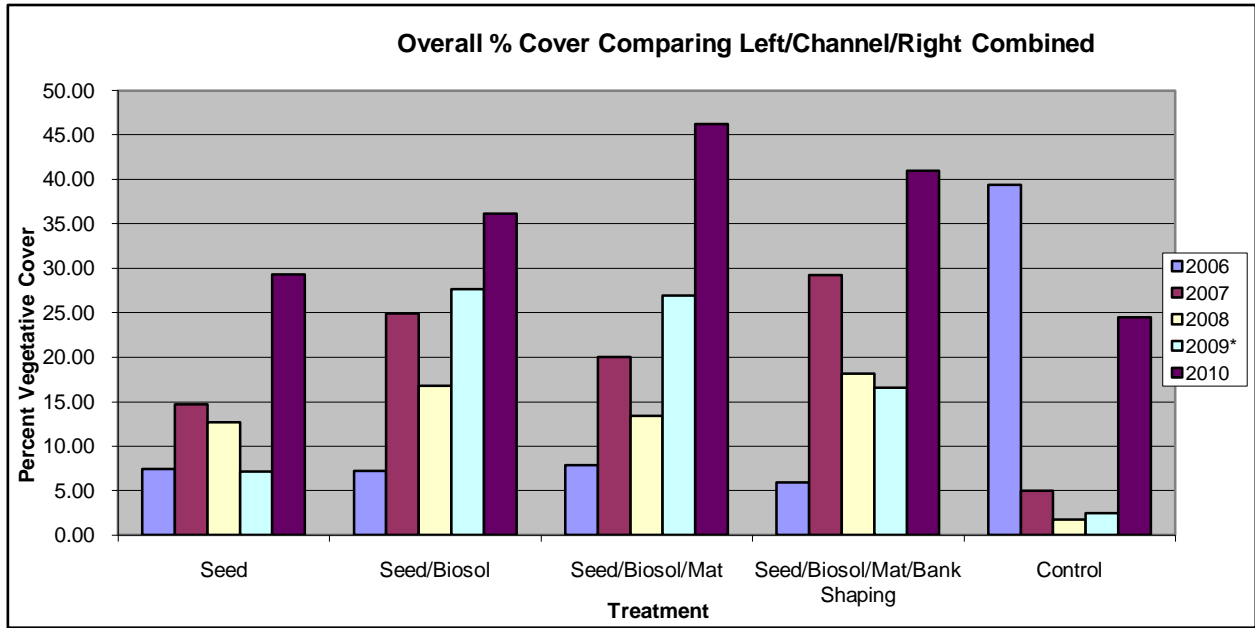
Figure 7: Overall Percent Cover of Left Bank, Channel, and Right Bank combined, by year.
 * 2009 data is incomplete and shown for comparison purposes only

Vegetation surveys conducted over the monitoring period (2006-10) showed that all four vegetation treatments were successful in increasing vegetation cover within the study plots by the end of the monitoring period and that vegetation cover was greater than that observed in the untreated control plots (Figure 7). The combination of Seed/BioSol/Erosion Control Matting (ECM) was the most effective resulting in a 5th year vegetative cover of 46.24%. In comparison, aggregated vegetation cover in the untreated control plots was 24.5%. The combination of Seed/BioSol/ECM/Bank Shaping was the second most effective treatment with a 5th year vegetation cover of 40.96%. Treatment with only seed, or seed and BioSol, were less effective with vegetation cover percentages of 29.33 and 36.15, respectively.

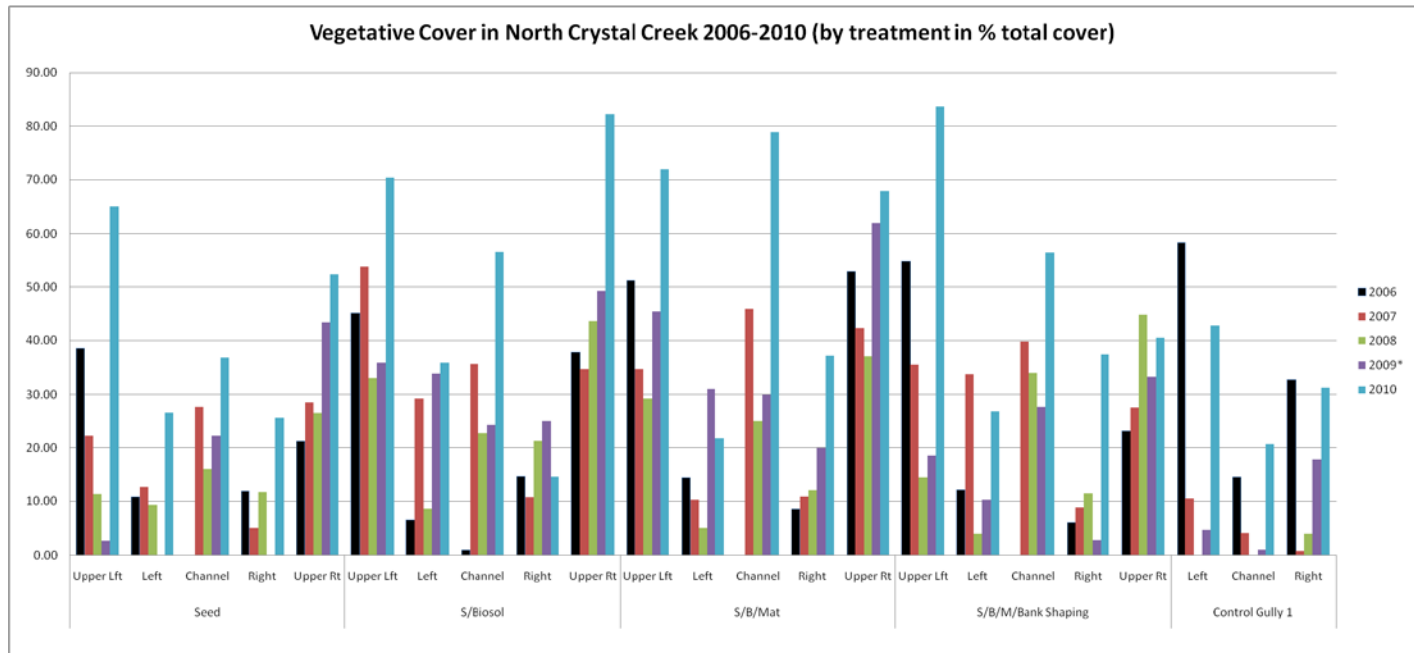
Figure 8: Comparison of % Vegetation Cover by Treatment Type and Gully Morphology.
 * 2009 data is incomplete and shown for comparison purposes only

Analysis of the percent change in vegetation cover from the initial year in 2006 to 2010 by gully morphology also shows that Seed/BioSol/ECM was the most effective, with an increase from 0% to 78.9 percent cover in the channel, 14.43% to 21.74% on the left bank, and 8.5% to 37.24% on the right bank (Figure 8). Applying seed only was the least effective treatment, however an increase in vegetative cover from 0% to 36.78% in the channel, 10.81% to 26.67% on the left bank, and from 11.93% to 25.62% on the right bank was observed. Results for the untreated control plots were mixed. In 2006, aggregated vegetation cover for the control plots was 14.53% in the channel, 58.33% on the left bank, and 32.77% on the right bank. By 2008, these numbers had dropped to 0, 0, and 4 percent, respectively. However by 2010, the aggregated vegetation cover for the control plots was 20.78% in the channel, 42.86% on the left bank, and 31.25% on the right. These results are comparable to the seed only treatment but are significantly less than the other treatments.
